2018 Annual Summary Report
Operations and Maintenance Plan
Oeser Superfund Site
Bellingham, Washington

Prepared by Christopher M. Secrist,
The Oeser Company
February 15, 2019

Sample Cap and Stormwater Drainage System Inspection Log

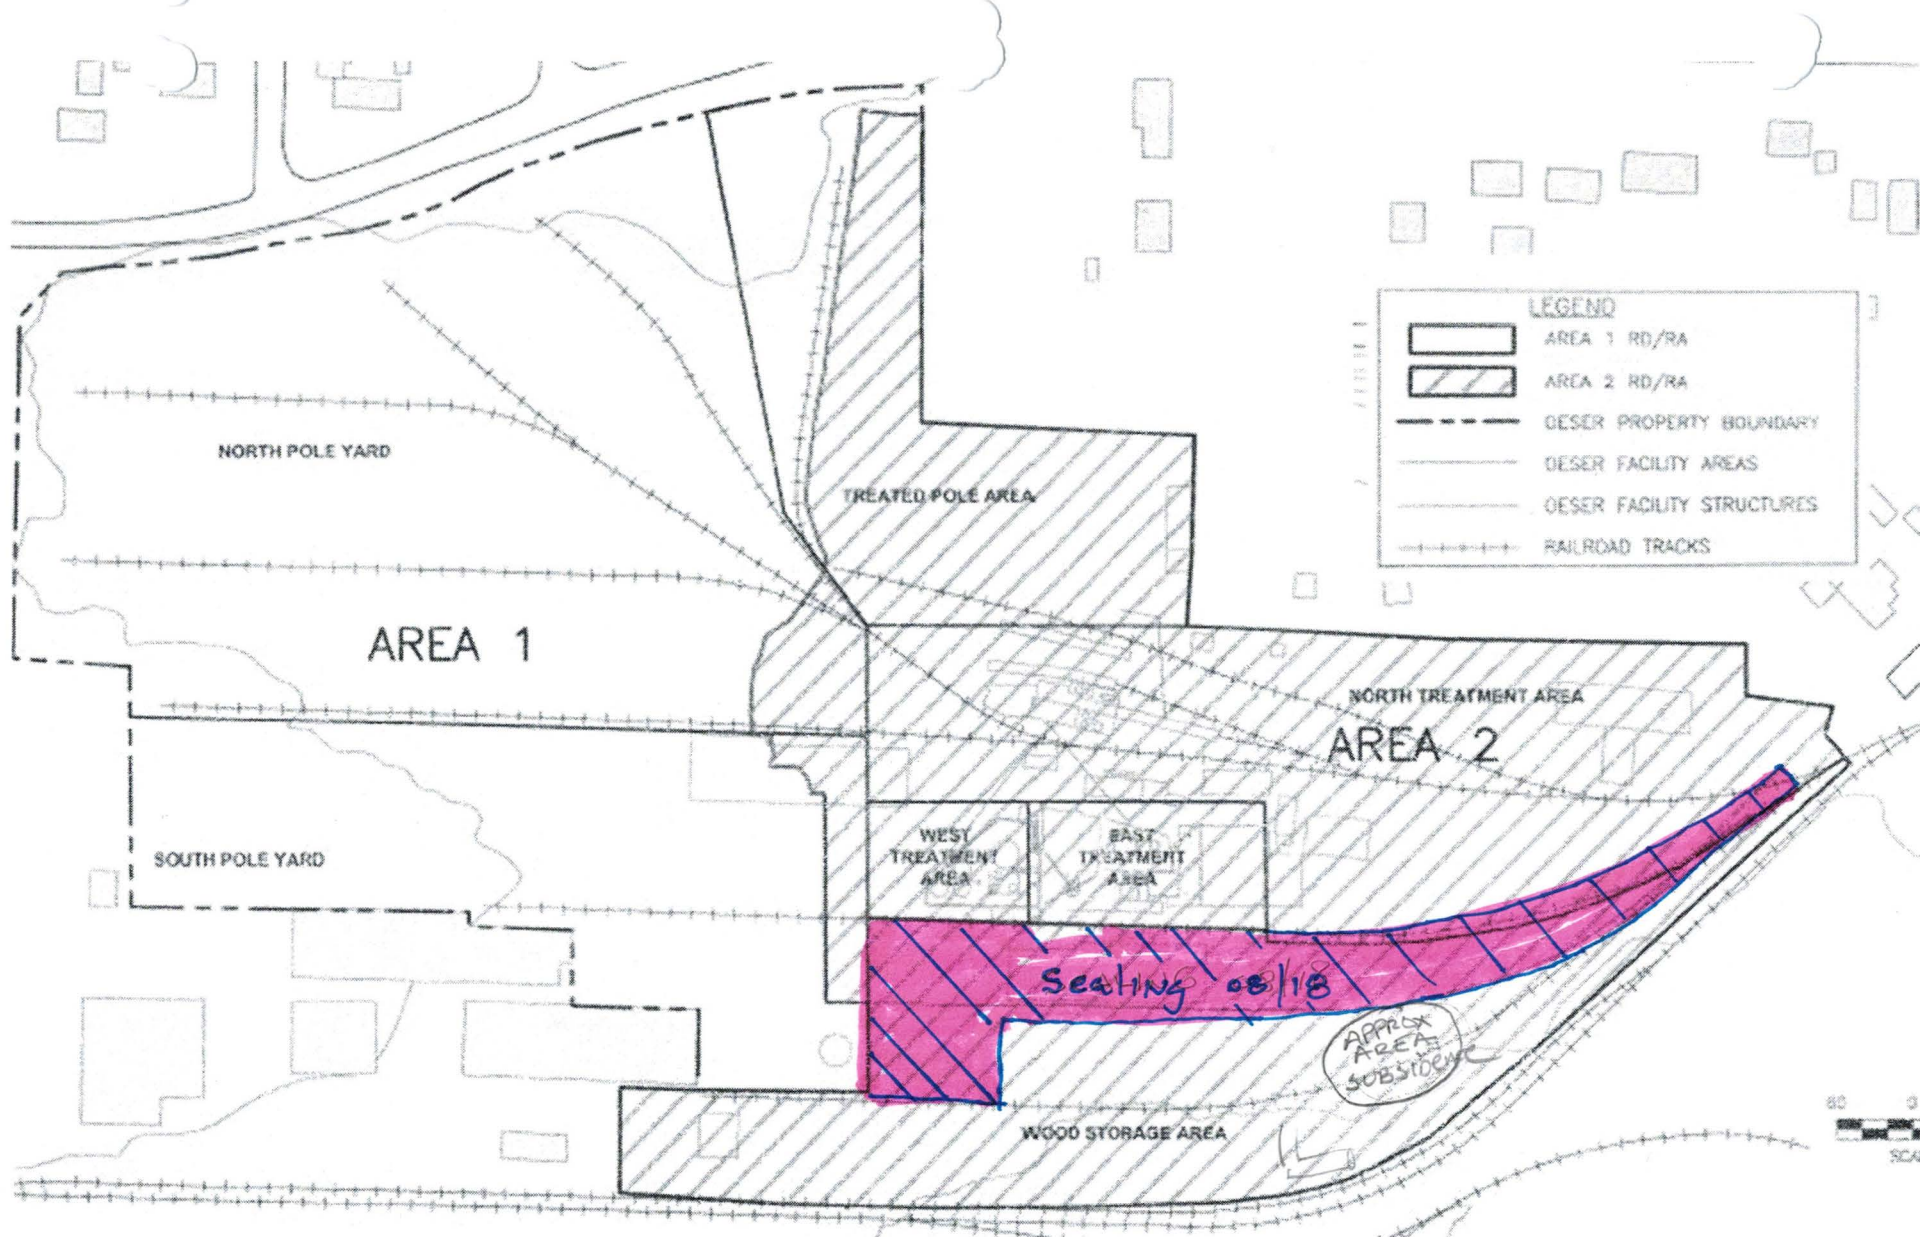
USE THIS MAP TO SHOW APPROXIMATE AREA THAT ACTION WAS TAKEN

Cap Damage – Location and Description Good except area of
subsidence in barkie area - noted on map

- Are cracks greater than ¼ inch wide visible? See notes
 - ▶ Width of cracks _____
 - ▶ Spacing of cracks _____
 - ▶ Depth of cracks _____
 - ▶ Location of cracks _____
 - ▶ Length of cracks _____
- Is settlement visible? Yes
 - ▶ Is settlement greater or less than 3 inches? NO
 - ▶ Dimension of settlement area ≈ 50' Ø
 - ▶ Depth of settlement 1"
 - ▶ Location of cracks _____

Notes: Cracks developing South of Tank Farm - area sealed
w/ 2 coats sealer

Date of Action: 8/18/2018 Action Performed By: Jon Gurschel

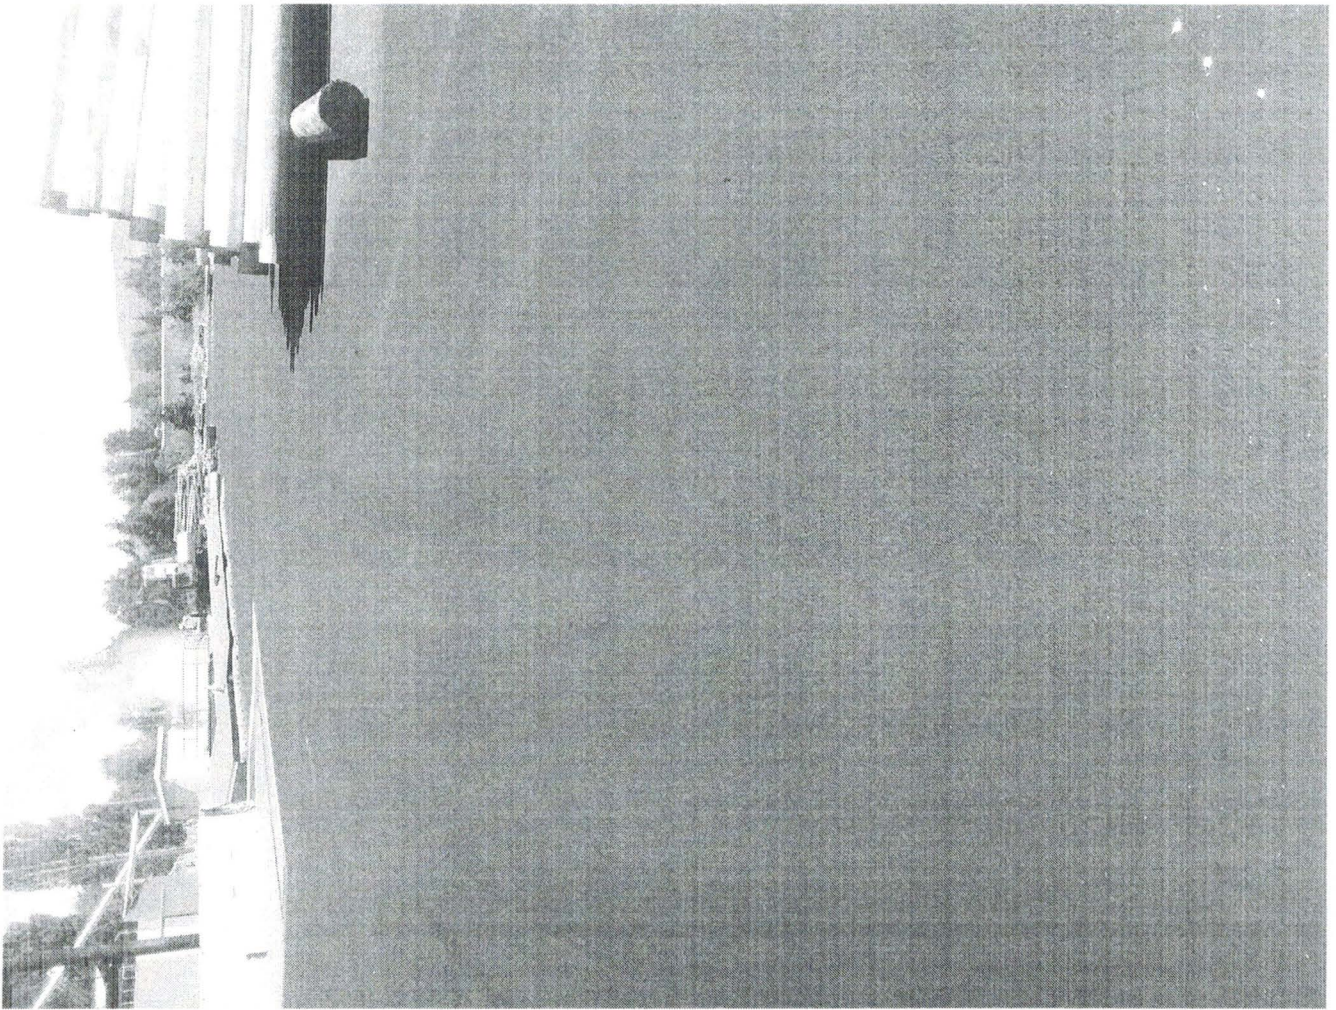
Wood Storage Area sealing

8/18

- The Oeser Company performs monthly site inspections.
- The annual inspection log is attached. No conditions which impact the performance of the Remedial Action were observed in 2018.
- Resurfacing of the Wood Storage Area was performed in August 2018.

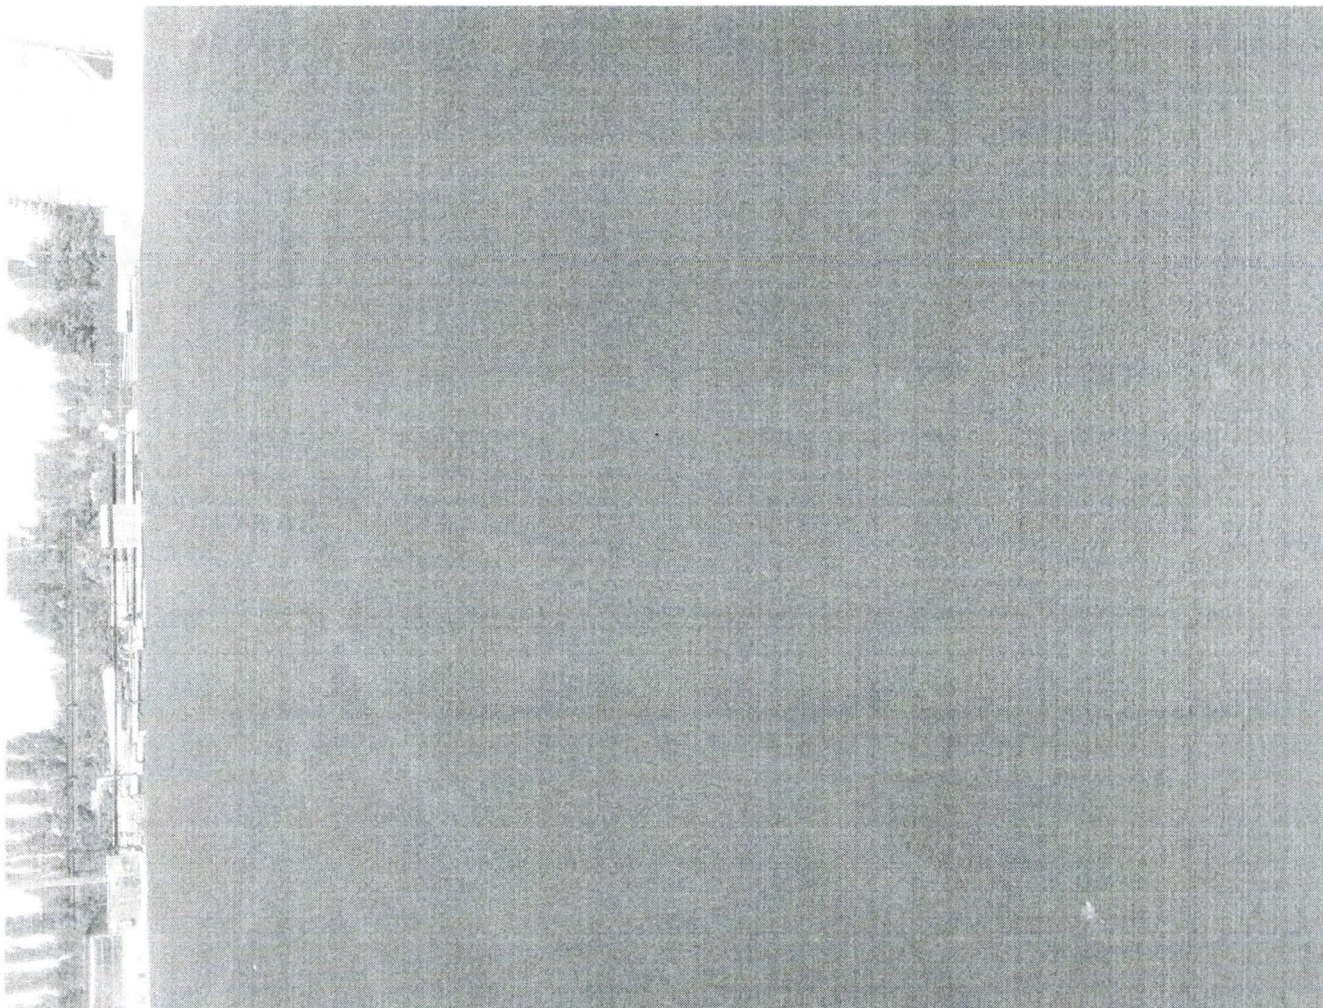
Wood Storage Area sealing

8/18
